**Flood Control Project Maintenance
Levee Inspections**
LMA District Cover Sheet
Spring 2017 Levee Inspection Results

Reclamation District No. 0563 Tyler Island

Unit Cover Sheet

| Waterway | | | Bank | Unit Miles |
|---|---|---|---|---|
| Unit No. 01 Georgiana Slough (Tyler Island) | | | Left | 12.11 |

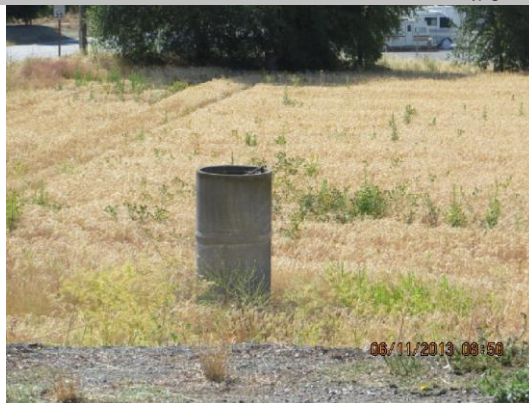
Photo 1 of 1 : UCIP_SP_2017_14864_24503.jpg

36-inch concrete standpipe on LS toe.

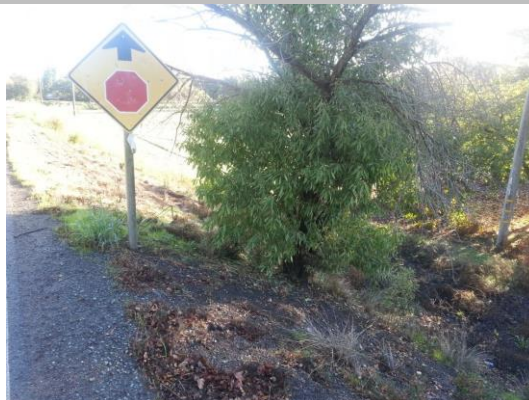
Photo 1 of 1 : SP_2017_RD0563_210_59_20170313_00047.jpg

Looking north at untrimmed tree on landward slope.

| Dead tree should be removed. | | | | | |

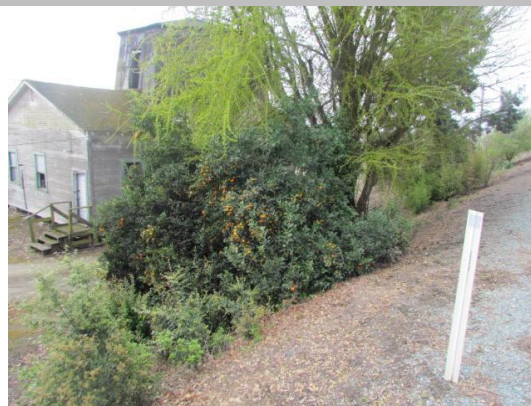
Photo 1 of 1 : SP_2017_RD0563_210_28_20170313_00024.jpg

Looking southeast at landscaping on landside slope and toe.

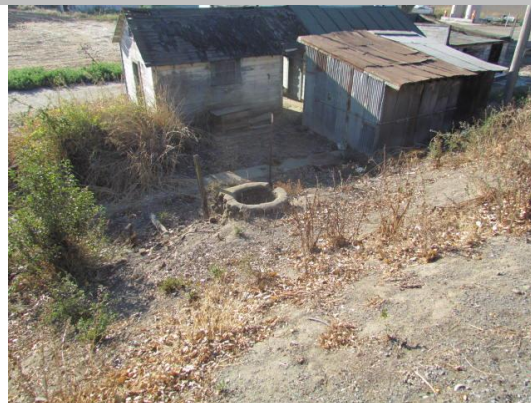
Photo 1 of 3 : SP_2017_RD0563_210_10_20170313_00009.jpg

| Tool shed and fire pit on landward slope and toe. | | | | | |

Looking east at fire pit on landward slope.

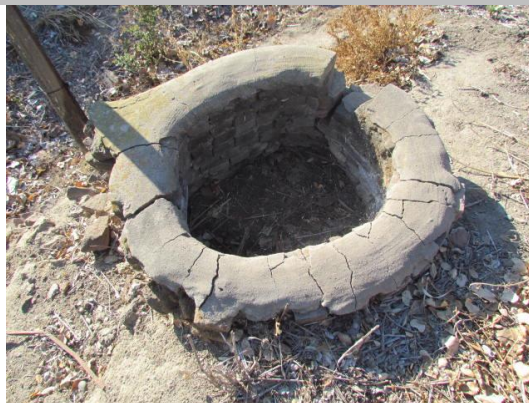
Photo 2 of 3 : SP_2017_RD0563_210_10_20170313_00010.jpg

| Tool shed and fire pit on landward slope and toe. | | | | | | |

Looking southeast at fire pit on landward slope.

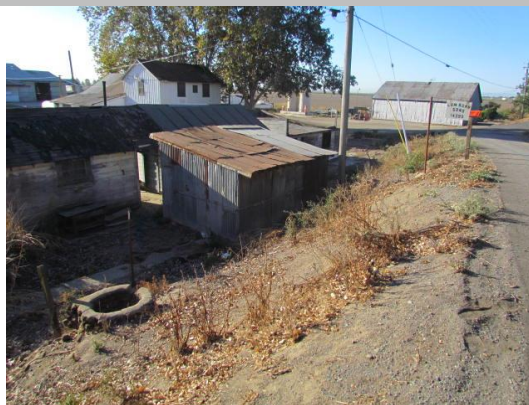
Photo 3 of 3 : SP_2017_RD0563_210_10_20170313_00011.jpg

Looking southeast at storage shed at landward toe.

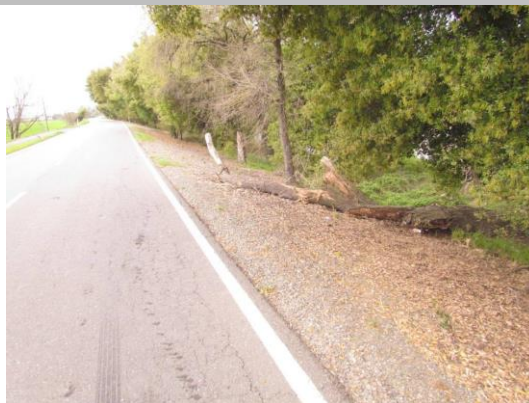
Photo 1 of 2 : SP_2017_RD0563_210_32_20170316_00235.jpg

| Tree fallen across waterward slope. | | | | | |

Looking downstream at tree branch on waterward slope. (Spring 2017)

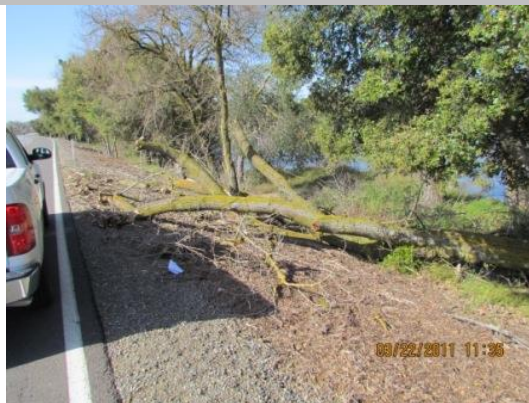
Photo 2 of 2 : SP_2017_RD0563_210_32_20170313_00027.jpg

| Tree fallen across waterward slope. | | | | | | |

Looking downstream at fallen tree limb on waterside slope. (Spring 2016)

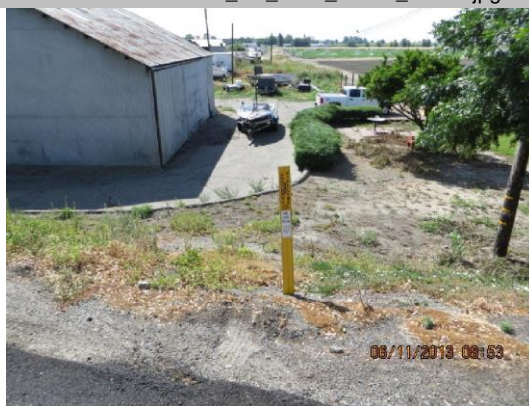
Photo 1 of 2 : UCIP_SP_2017_14865_24505.jpg

Gasline marker on LS shoulder.

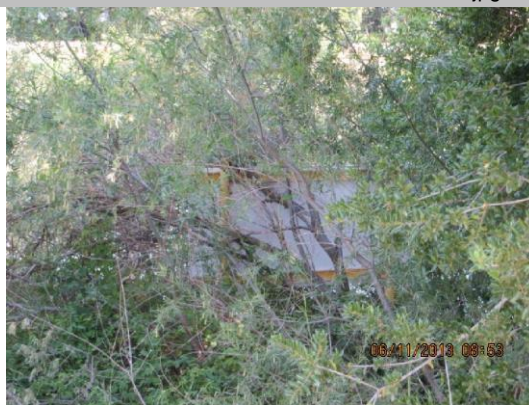
Photo 2 of 2 : UCIP_SP_2017_14865_24504.jpg

Gasline warning sign covered in vegetation on WS slope.

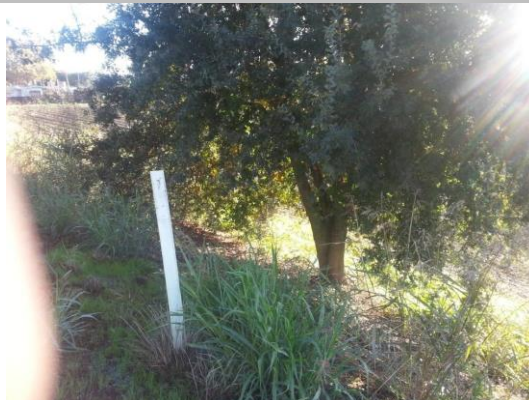
Photo 1 of 1 : SP_2017_RD0563_210_168_20170313_00139.jpg

Looking east at untrimmed tree on landward slope.

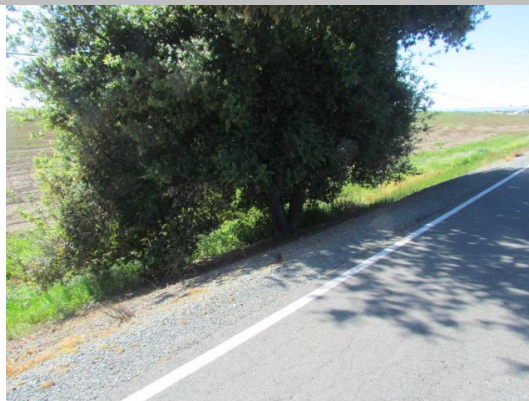
Photo 1 of 1 : SP_2017_RD0563_210_135_20170313_00111.jpg

| Untrimmed tree on landward slope. | | | | | |

Looking southeast at untrimmed tree on landward slope.

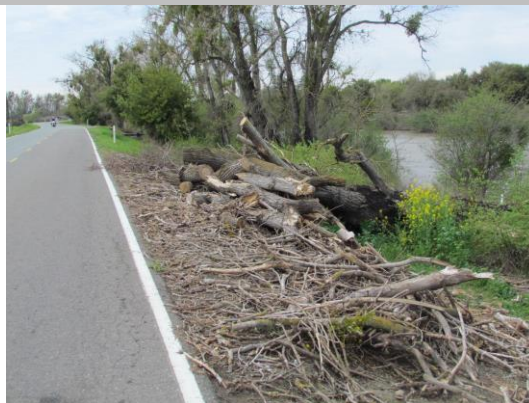
Photo 1 of 1 : SP_2017_RD0563_210_119_20170316_00236.jpg

Looking south at pruning pile on waterward shoulder and slope.

| Large fallen tree pruning piles on waterward slope should be discard. | | | | | |

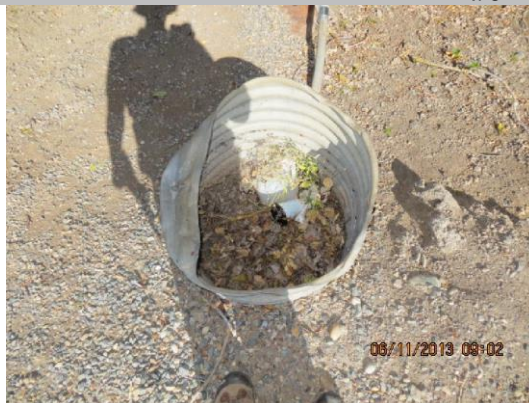
Photo 2 of 3 : UCIP_SP_2017_14866_24507.jpg

| FS_ID:14866 DS_ID:20130 EP_NO: 11218 Repair Type: Non-Urgent Crossing Status: Found UCIP Comments: Pipe leaking at various points on WS berm. Failure on berm may indicate potential for failure within the levee. Good candidate for video inspection. FIELD_STRUCT_DESC: 12-inch steel pipe through the levee 5.0 feet below the crown. Walkway to pump on pile structure in stream. Siphon breaker in a 24-inch CMP riser on the waterward shoulder. 1" air and vacuum valve and a 15' tall by 36" diameter concrete standpipe at the LS toe (ABO No. 11218, 1975). Originally included in the 1954 O&M manual. FS Date: 6/11/2013 | | | | | | |

Siphon breaker not visible in 24-inch CMP riser on WS shoulder.

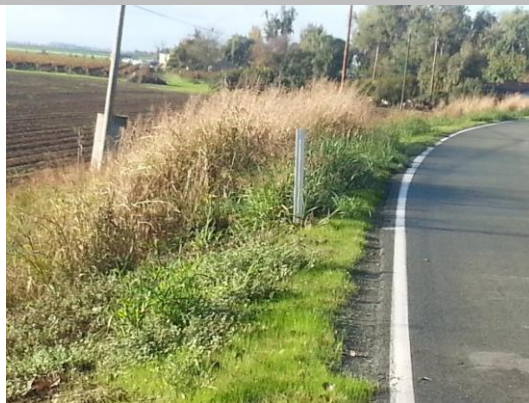
Photo 1 of 2 : SP_2017_RD0563_210_138_20170313_00113.jpg

| Dense johnson grasses on landward slope. | | | | | |

Looking west at dense veg on landward slope.

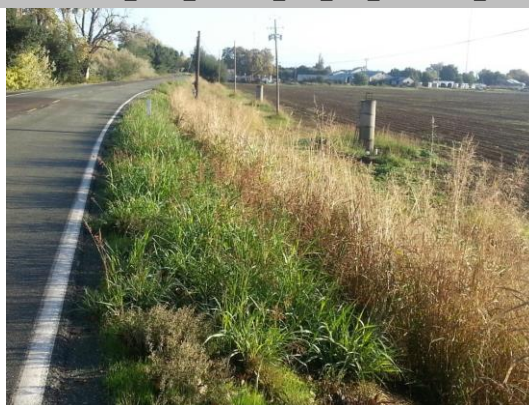
Photo 2 of 2 : SP_2017_RD0563_210_138_20170313_00114.jpg

Looking east at dense veg on landward slope.

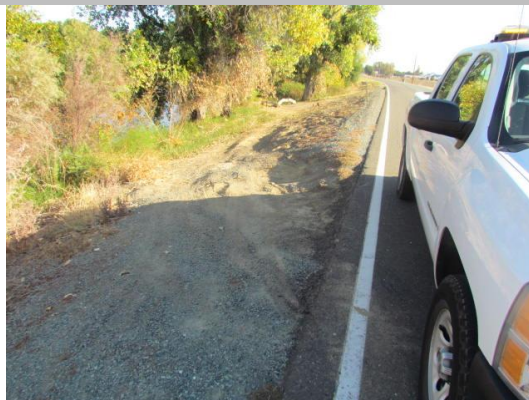
Photo 1 of 1 : SP_2017_RD0563_210_34_20170313_00029.jpg

| Slope damage is due to fishermen vehicle traffic. | | | | | |

Looking northwest at slope damage caused by vehicle traffic.

| S3 : Repair the levee slope damaged by vehicle traffic and prevent access where possible. | | | | | |

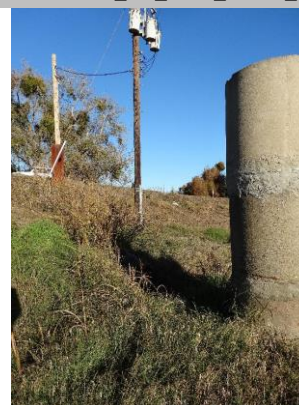
Photo 1 of 3 : UCIP_SP_2017_51626_76821.jpg

| FS_ID:51626 DS_ID:20131 EP_NO: 11203 Repair Type: Urgent Crossing Status: Found UCIP Comments: 12/02/2016 Same as last inspection signs of leak are still present on both LS and WS. Recommend internal inspection of the pipe integrity though the levee to determine cause of depression on levee (either leak or poor compaction). Pipe debris previous noted on WS has been removed. (O. Magana - DWR UCIP)06/11/2013 Signs of leak in pipe at levee slope on both LS and WS where pipe enters levee. Moist soil at LS toe indicates possible internal leak. Evidence of recent pipe repair on WS. Pipe debris on WS toe should be removed. (W. Wylie - DWR UCIP) FIELD_STRUCT_DESC: ** 12-inch steel irrigation pipe through the levee, 5 feet below the crown. Slant pump located on the waterside (WS). Siphon breaker and switch box also located on the WS slope. Service pole is located on the landside (LS) slope. (12-inch pipe authorized under Automatic Board Order (ABO) issued as Permit No. 11203, 1971 - Delta Farmers, Inc.) This crossing has been replaced with 6-inch under DSID 25486, as reported by DWR inspector Richard Willoughby during his Spring 2017 inspection. [Additional Reference(s): DWR Levee Log, 2005. USACE Sacramento O&M Manual Unit 103, June 1954 (HLM 0.73)] FS Date: 12/2/2016 | | | | | |

View of LS slope.

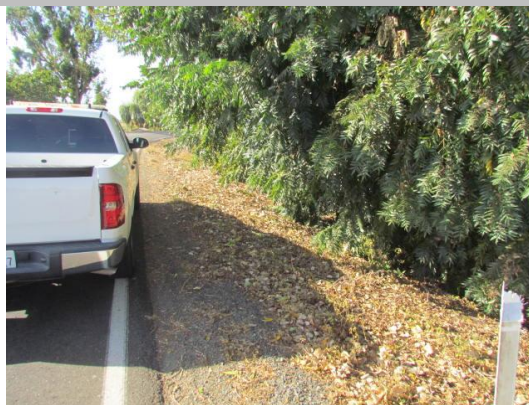
Photo 2 of 2 : SP_2017_RD0563_210_3_20170313_00002.jpg

Looking east at untrimmed trees on waterward slope and toe. (Spring 2016)

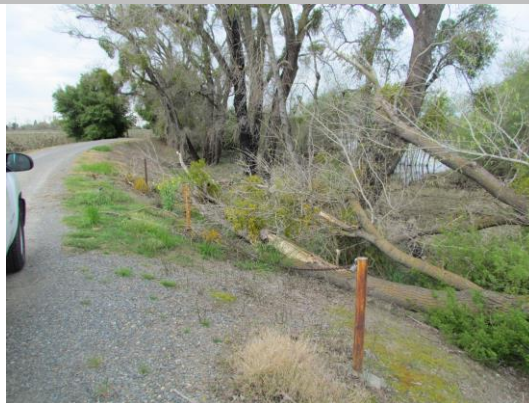
Photo 1 of 1 : SP_2017_RD0563_210_120_20170316_00237.jpg

| Fallen tree on waterward slope. | | | | | |

Looking southwest at fallen tree on waterward slope.

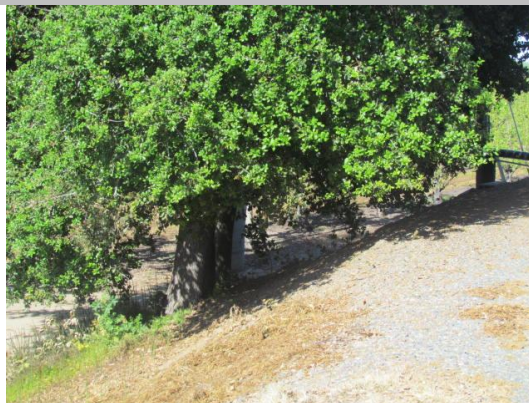
Photo 1 of 1 : SP_2017_RD0563_210_755_20170313_00144.jpg

Looking southeast at untrimmed tree on landward slope.

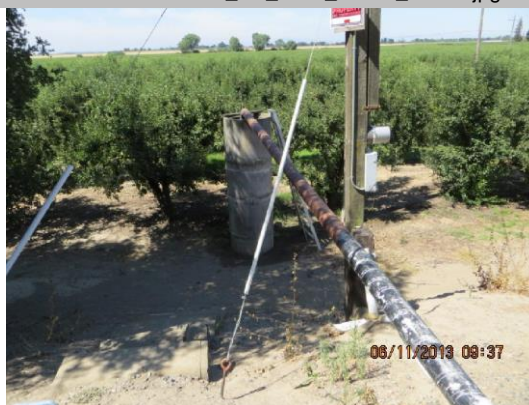
Photo 1 of 3 : UCIP_SP_2017_14870_24517.jpg

6-inch pipe and concrete standpipe on LS. Electrical conduit runs parallel to pipe to pump house on WS.

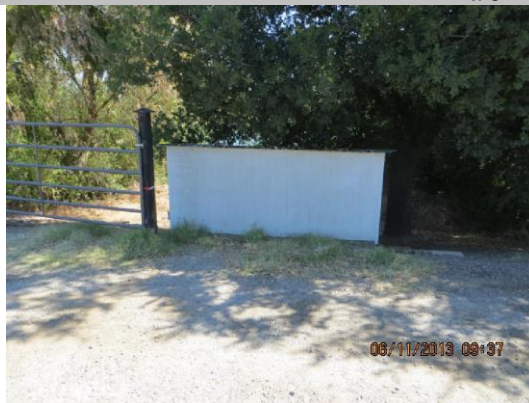
Photo 2 of 3 : UCIP_SP_2017_14870_24516.jpg

Pumphouse on WS shoulder.

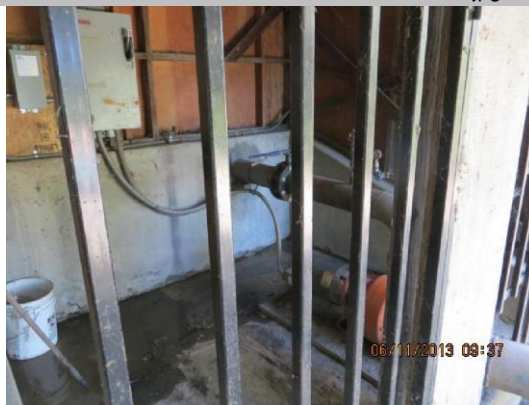
Photo 3 of 3 : UCIP_SP_2017_14870_24515.jpg

Butterfly valve, vent and pump in pumphouse on WS shoulder.

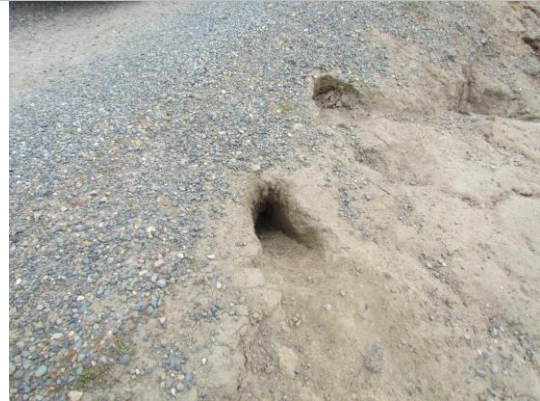
Photo 1 of 1 : SP_2017_RD0563_210_121_20170316_00238.jpg

| Several large rodent holes on landward slope. | | | | | |

Looking at typical rodent hole within this reach.

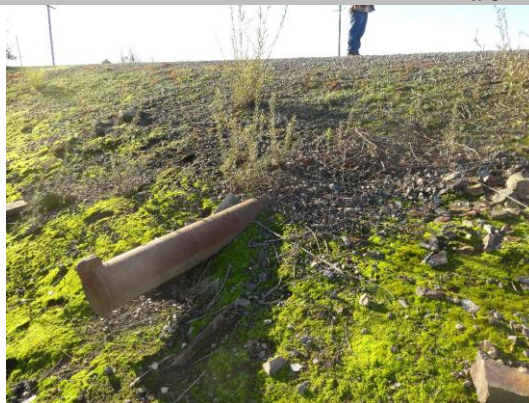
Photo 2 of 3 : UCIP_SP_2017_51448_76828.jpg

Pipe with flap visible on WS.

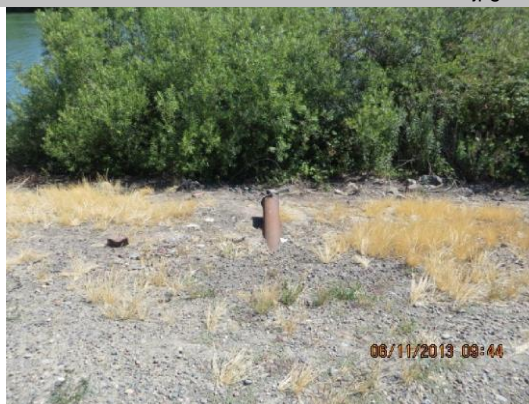
Photo 3 of 3 : UCIP_SP_2017_51448_24524.jpg

Pipe and flapgate on WS slope.

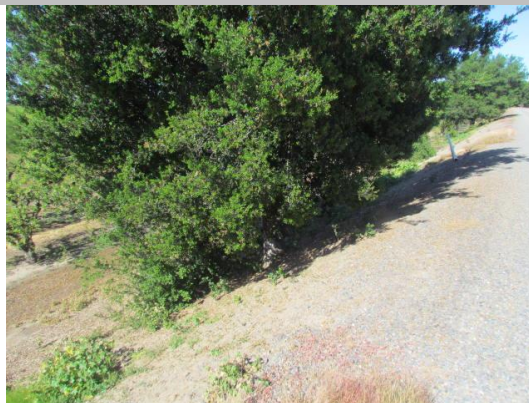
Photo 1 of 1 : SP_2017_RD0563_210_756_20170313_00145.jpg

Looking southeast at untrimmed tree on landward slope.

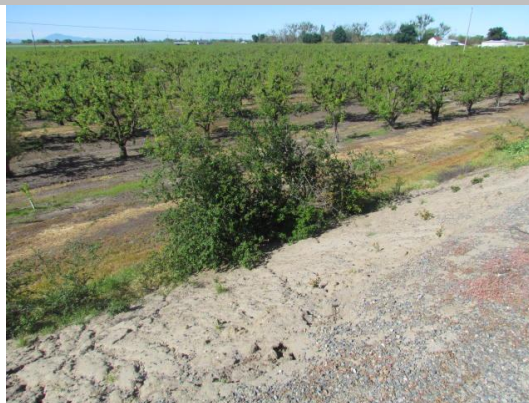
Photo 1 of 1 : SP_2017_RD0563_210_132_20170313_00109.jpg

Looking southeast at several small trees at landward toe.

| Small trees on landward shoulder be removed. | | | | | |

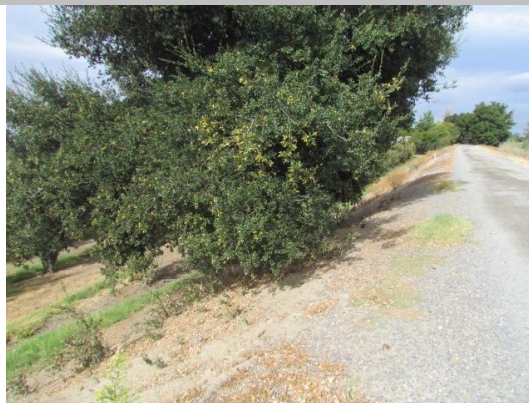
Photo 1 of 1 : SP_2017_RD0563_210_757_20170313_00146.jpg

Looking at untrimmed trees on landward slope.

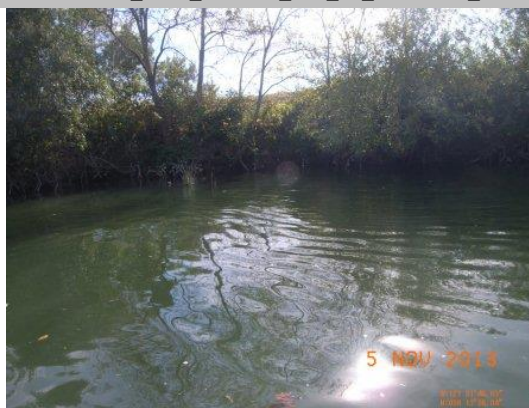
Photo 1 of 1 : SP_2017_RD0563_210_48_20170313_00041.jpg

| 2011 - Short sections of eroding bank at the waterline and holes in toe of levee. 2012 - Site extended upstream. 2013 - Erosion pockets filled with an insufficient amounts of revetment. 2015: Last observed in 2013. [2015 Site ID: GEO_11-0_L] | | | | | |

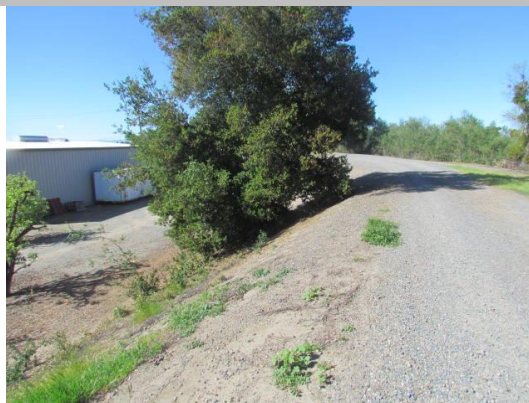
Photo 1 of 1 : SP_2017_RD0563_210_140_20170313_00120.jpg

| Untrimmed tree blocking view of landward slope and toe. | | | | | |

Looking southeast at untrimmed tree at landward toe.

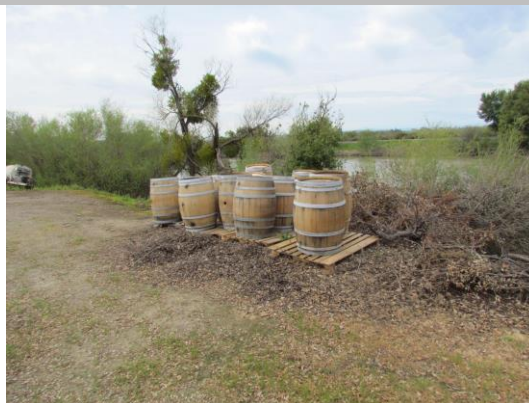
Photo 1 of 2 : SP_2017_RD0563_210_122_20170316_00239.jpg

| Landowner storing wine barrels and prunings on waterward slope. | | | | | |

Looking west at wine barrels and prunings on waterward shoulder and slope.

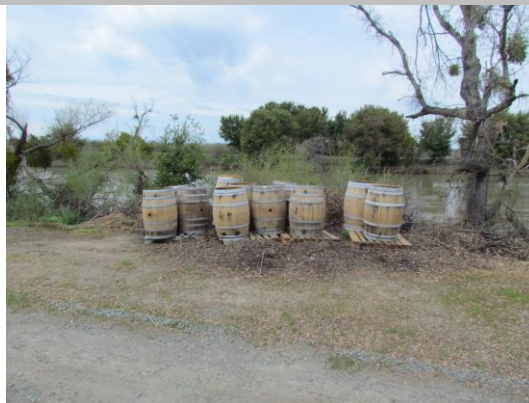
Photo 2 of 2 : SP_2017_RD0563_210_122_20170316_00240.jpg

| Landowner storing wine barrels and prunings on waterward slope. | | | | | | |

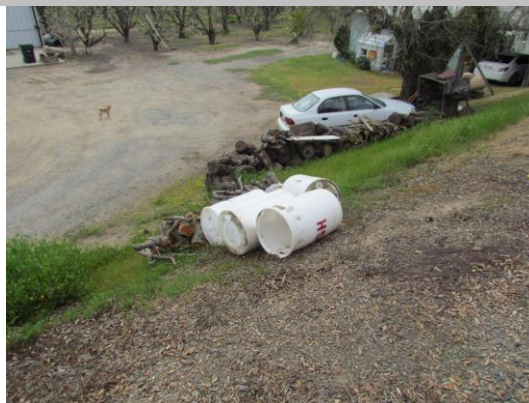
Photo 1 of 2 : SP_2017_RD0563_210_134_20170316_00241.jpg

| Landowner stock piling firewood and other garbage at landward toe. | | | | | |

Looking east at firewood and empty containers on landward slope.
(Spring 2017)

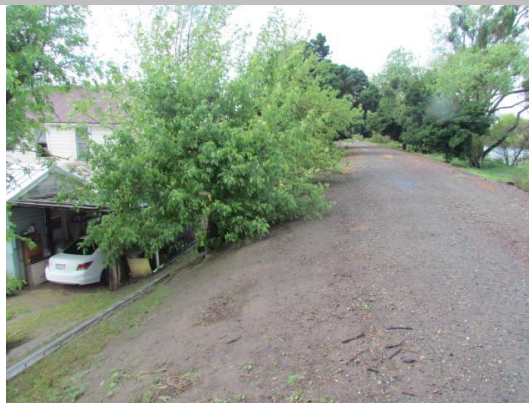
Photo 1 of 1 : SP_2017_RD0563_210_5_20170313_00003.jpg

Looking south at untrimmed trees on landward slope.

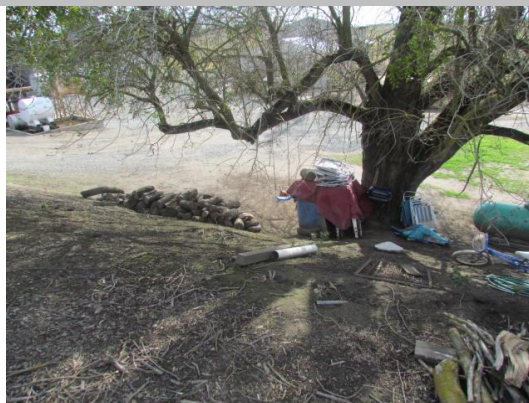
Photo 1 of 2 : SP_2017_RD0563_210_57_20170313_00045.jpg

| Landowner is stacking firewood and other items on landside slope and toe. | | | | | |

Looking east at firewood and other materials stored on landside slope and toe.

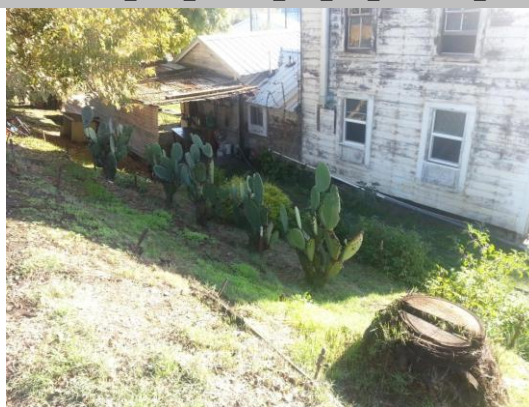
Photo 2 of 2 : SP_2017_RD0563_210_170_20170313_00142.jpg

Looking southeast at cactus on landward slope.

| Remove cactus on landward slope. | | | | | |

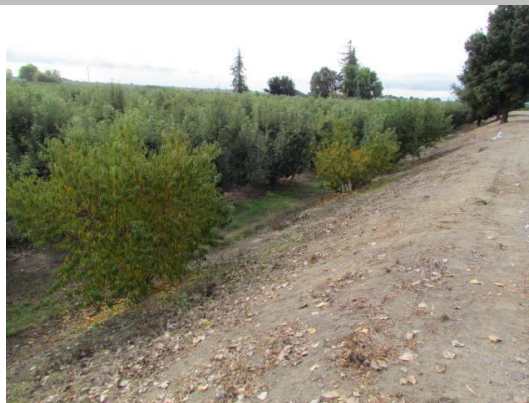
Photo 1 of 1 : SP_2017_RD0563_210_64_20170313_00050.jpg

| Trees located at landside toe. | | | | | |

Looking southeast at fruit trees on landside toe.

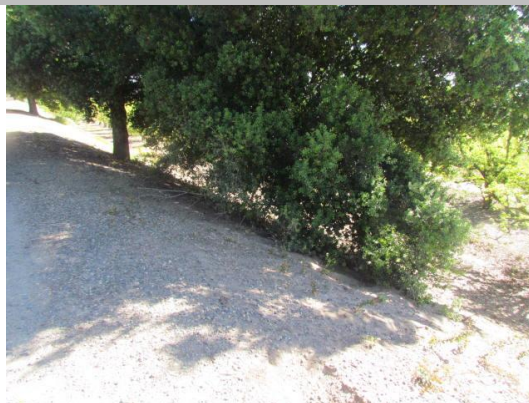
Photo 1 of 1 : SP_2017_RD0563_210_79_20170313_00077.jpg

Looking northeast at untrimmed trees on landward slope and toe.

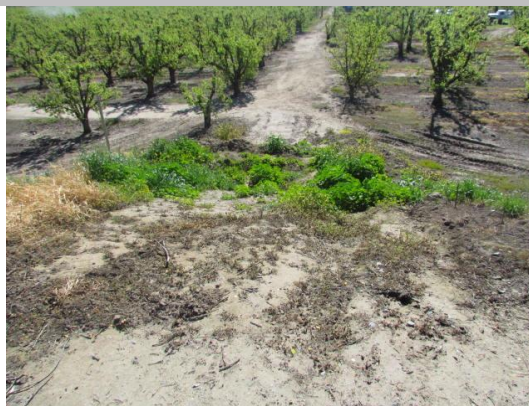
Photo 1 of 3 : SP_2017_RD0563_210_150_20170313_00130.jpg

| Unauthorized ramp on landward slope. | | | | | |

Looking southeast at ramp on landward slope.

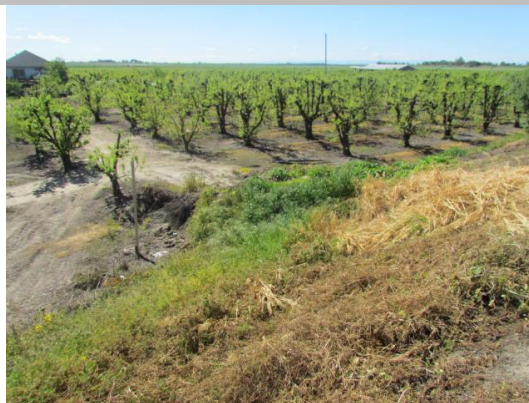
Photo 3 of 3 : SP_2017_RD0563_210_150_20170313_00132.jpg

| Unauthorized ramp on landward slope. | | | | | | |

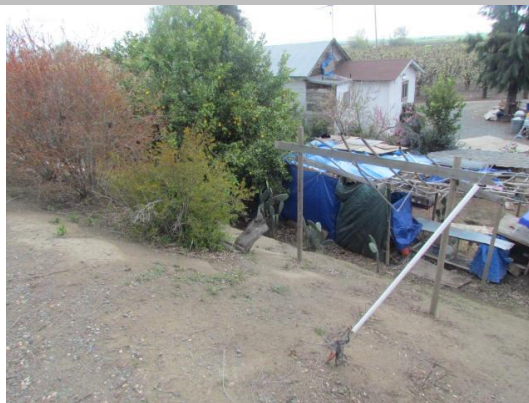
Photo 1 of 3 : SP_2017_RD0563_210_8_20170313_00006.jpg

| Tool shed, animal storage container, and landscaping on waterside slope and toe. | | | | | |

Looking east at landscaping and animal containers on the landside slope and toe.

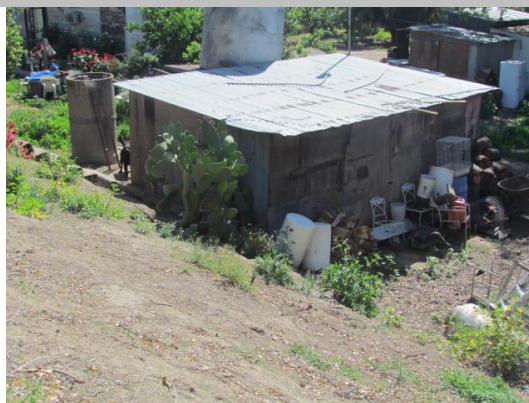
Photo 2 of 3 : SP_2017_RD0563_210_8_20170313_00007.jpg

Looking northeast at a tool shed on the landward toe.

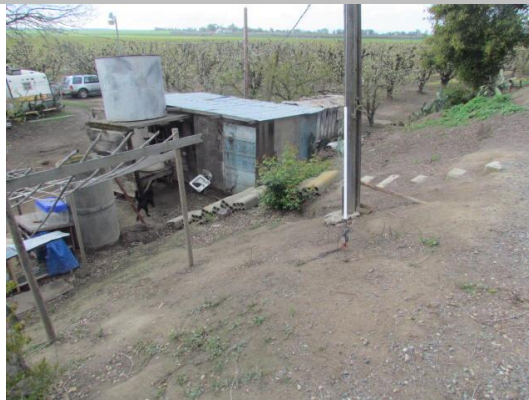
Photo 3 of 3 : SP_2017_RD0563_210_8_20170313_00008.jpg

Looking southeast at a tool shed at the landside toe.

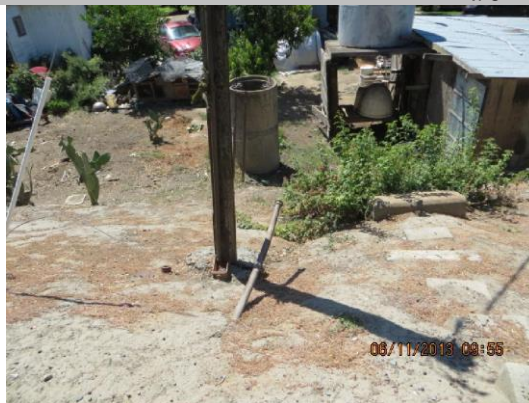
Photo 1 of 2 : UCIP_SP_2017_14873_24527.jpg

FS_ID:14873
DS_ID:20134
EP_NO: N/A
Repair Type: Non-Urgent
Crossing Status: Found
UCIP Comments: Pipe open on LS and should be removed.
FIELD_STRUCT_DESC: *ABANDONED* 2-inch pipe through levee 2.0 feet below the crown.
FS Date: 6/11/2013

Pipe visible on LS slope at JP.

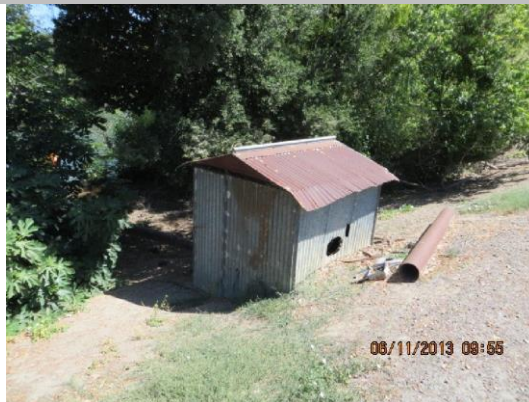
Photo 2 of 2 : UCIP_SP_2017_14873_24526.jpg

Pipe goes to pumphouse on WS slope.

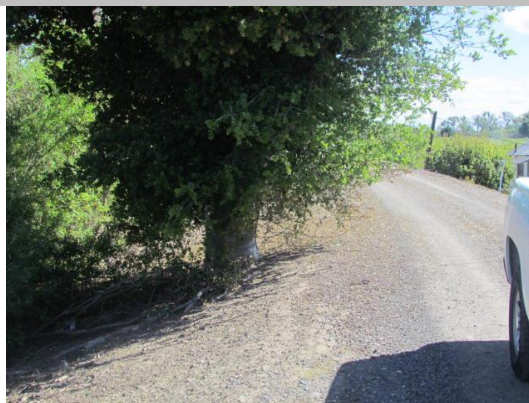
Photo 1 of 1 : SP_2017_RD0563_210_759_20170313_00147.jpg

Looking northwest at untrimmed trees on waterward slope and toe.

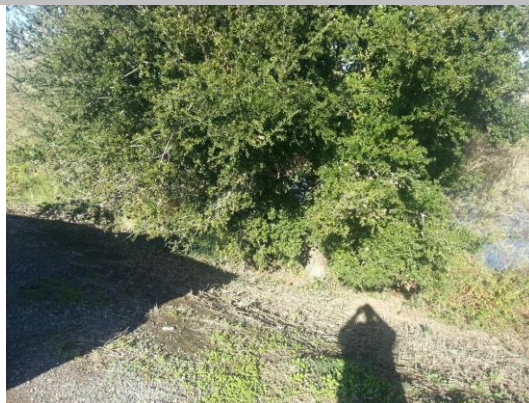
Photo 1 of 1 : SP_2017_RD0563_210_760_20170313_00148.jpg

Looking upstream at untrimmed tree on waterward slope.

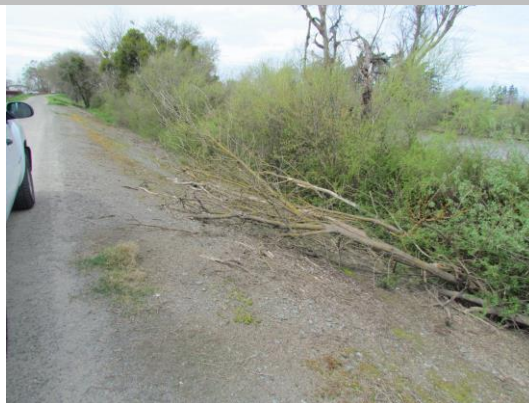
Photo 1 of 1 : SP_2017_RD0563_210_123_20170316_00242.jpg

| Fallen tree on waterward slope. | | | | | |

Looking south at fallen tree on waterward slope.

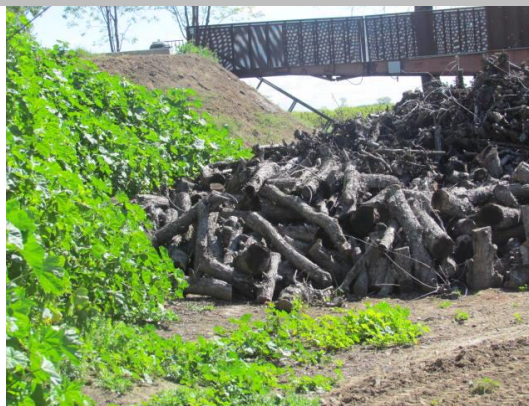
Photo 1 of 1 : SP_2017_RD0563_210_161_20170313_00136.jpg

| Landowner stocking firewood at landward toe. | | | | | |

Looking north at fireward at landward toe.

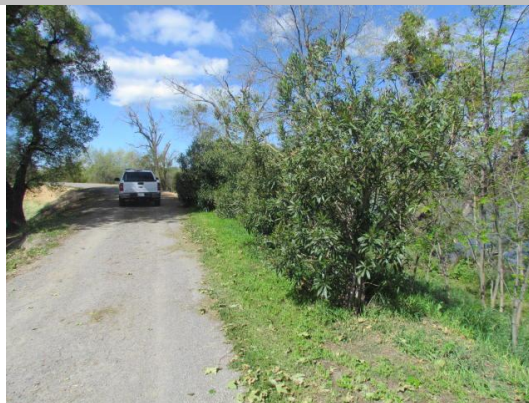
Photo 1 of 4 : SP_2017_RD0563_210_142_20170313_00123.jpg

| Landowner has planted oleander on waterward shoulder. | | | | | |

Looking southwest at oleanders on landward shoulder.

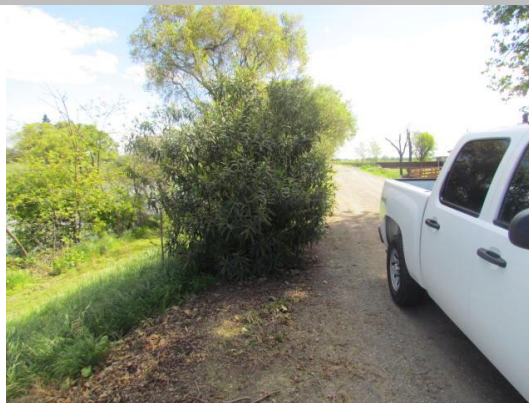
Photo 2 of 4 : SP_2017_RD0563_210_142_20170313_00124.jpg

| Landowner has planted oleander on waterward shoulder. | | | | | | |

Looking north at oleanders on landward shoulder.

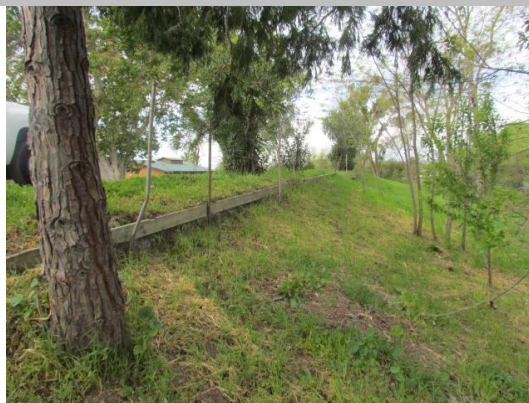
Photo 3 of 4 : SP_2017_RD0563_210_142_20170313_00125.jpg

Looking southeast at planting box on waterward shoulder.

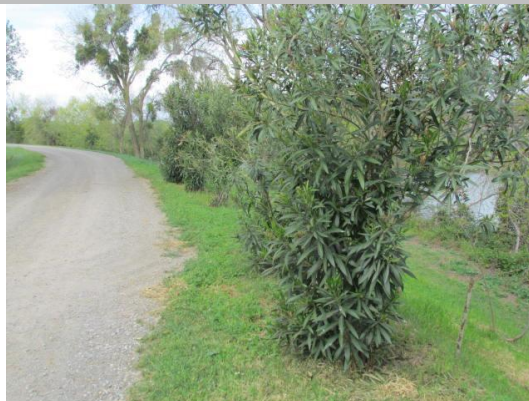
Photo 4 of 4 : SP_2017_RD0563_210_142_20170313_00126.jpg

Looking southwest at oleanders on waterward shoulder.

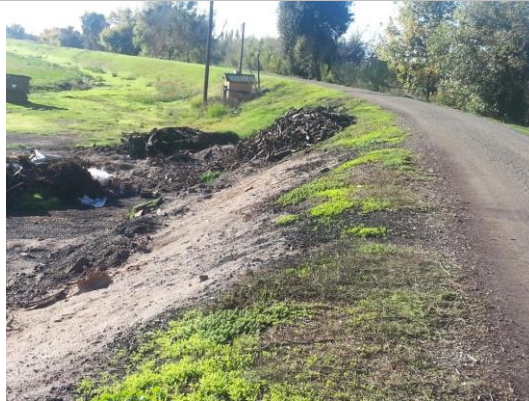
Photo 2 of 2 : SP_2017_RD0563_210_96_20170313_00097.jpg

| Pruning pile at landward toe. Landowner has burned pile, but pile is still within right away. | | | | | |

Looking downstream at prunings on landward slope. (Spring 2016)

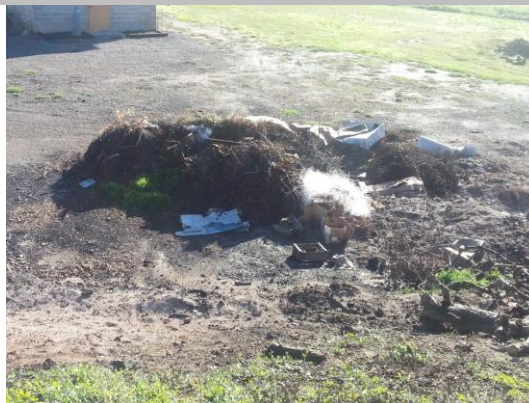
Photo 1 of 1 : SP_2017_RD0563_210_157_20170313_00135.jpg

| Landowner stockpiling garbage at landward toe. | | | | | |

Looking at garage pile at landward toe.

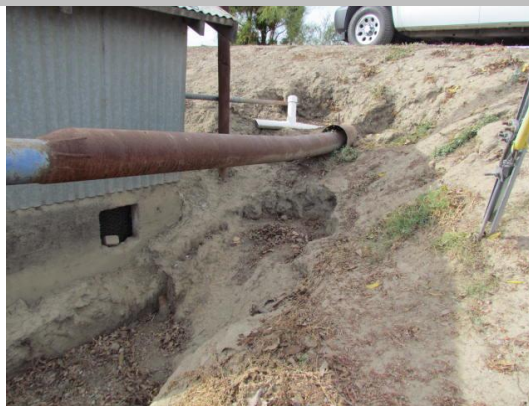
Photo 1 of 2 : SP_2017_RD0563_210_71_20170313_00055.jpg

| Erosion around irrigation pump house and pipe on landside slope. | | | | | |

Looking west at erosion at landside toe and slope next to pump house.

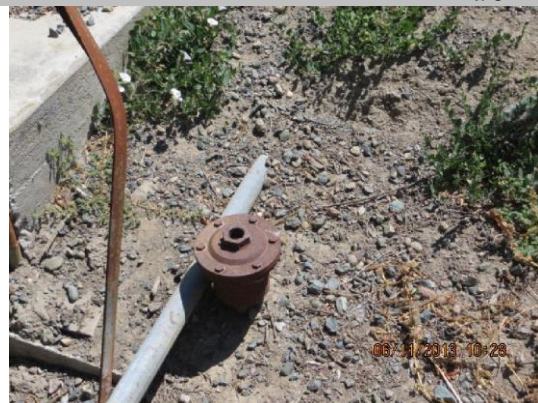
Photo 2 of 3 : UCIP_SP_2017_51449_24536.jpg

Siphon breaker and 1.5-inch galvanized iron electrical conduit.

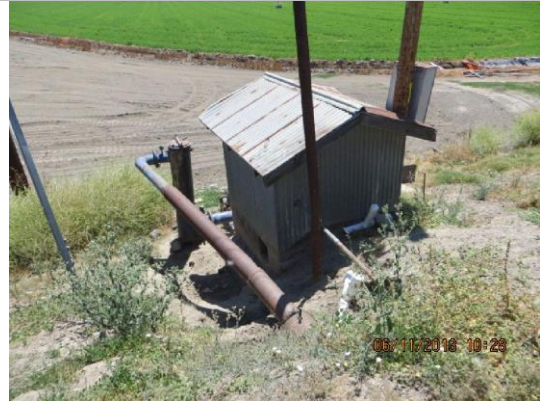
Photo 3 of 3 : UCIP_SP_2017_51449_24535.jpg

| FS_ID:51449 DS_ID:20136 EP_NO: 11204 Repair Type: Non-Urgent Crossing Status: Found UCIP Comments: 12/02/2016 same as last inspection. Crossing has been downgraded from "Urgent" to "Non-Urgent" no signs of leaks were visible from the surface. Owner will need to coordinate with the CVFPB to comply with Title 23 regarding the sleeved pipe and the non-annular space between the larger and smaller pipe. (O. Magana - DWR UCIP)06/11/2013 Annular space not grouted between 8-inch and 10-inch pipe and the metal walkway is structurally failing. (W. Wylie - DWR UCIP) FIELD_STRUCT_DESC: 8-inch steel irrigation pipe sleeved through a 10-inch pipe (12-inch referenced in permit recordation) through the levee, 4 feet below the crown. 1.5-inch electrical conduit through levee at same location. Pump located on pile structure located on the waterside (WS). Timber walkway to pump is located on the WS. Service pole is located on the landside (LS) slope. Siphon breaker on WS slope (12-inch pipe owner name change issued under Permit No. 11204-1, 2015 - J. Morris; 12-inch pipe authorized [HLM 1.99] under Automatic Board Order (ABO) issued as Permit No. 11204, 1971 - R. H. Elliott). [Additional Reference(s): DWR Levee Log, 2005. USACE Sacramento O&M Manual Unit 103, June 1954, (Station XX+XX)--unable to correlate crossing with O&M Manual]. FS Date: 12/2/2016 | | | | | |

Pipe at outlet on LS toe.

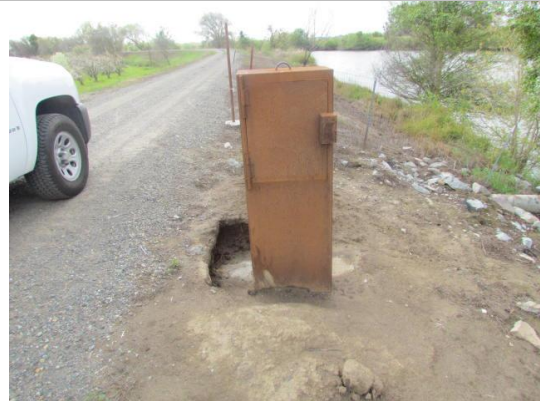
Photo 1 of 1 : SP_2017_RD0563_210_15_20170313_00015.jpg

| Landowner installed metal box around siphon breaker. | | | | | |

Looking south at siphon box installed on waterside shoulder.

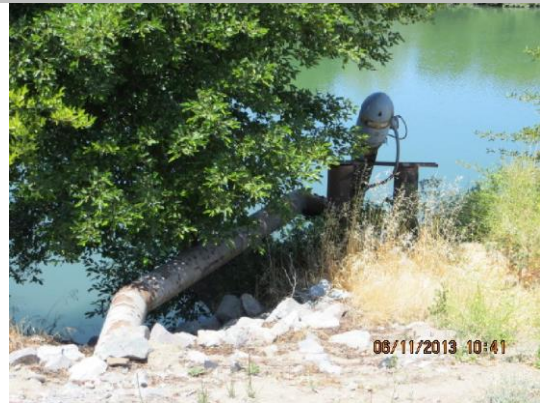
Photo 1 of 3 : UCIP_SP_2017_51450_24541.jpg

| FS_ID:51450 DS_ID:20176 EP_NO: 13311 Repair Type: Urgent Crossing Status: Found UCIP Comments: 12/02/2016 Dense vegetation around concrete standpipe located on LS toe assume issue recorded back in 2013 is still present due to the dense vegetation around structure. Need to contact owner. Owner will need to coordinate with the CVFPB to address the leaky concrete standpipe and the new metal case installed on WS slope (section of levee still opened). (O. Magana - DWR UCIP)06/11/2013 Concrete standpipe on LS toe is not functioning properly. Leaks springing up in the ground around the standpipe. This may erode the soil at base of levee. (W. Wylie - DWR UCIP) FIELD_STRUCT_DESC: 1 of 2: 12-inch steel irrigation pipe through levee, 3 feet below the crown. Slant pump is located on the waterside (WS) toe. 36-inch concrete standpipe and pipe works visible on the landside (LS) toe. Siphon breaker in 24-inch corrugated metal pipe (CMP) riser located on the LS shoulder. Pipe replaced 12-inch pipe from O&M manual/Permit No. 11207. (Permit No. 13311, 1982). (12-inch replaced under Permit No. 13311, 1981 - P. L. Lykins Ranch; 12-inch pipe authorized under Automatic Board Order (ABO) issued as Permit No. 11207, 1975 - Fong) FS Date: 12/2/2016 | | | | | |

Slant pump and pipe on WS slope.

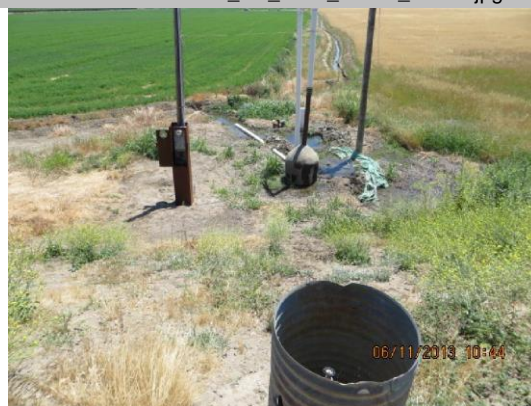
Photo 2 of 3 : UCIP_SP_2017_51450_24540.jpg

Concrete standpipe, and 24-inch CMP riser on LS of levee.

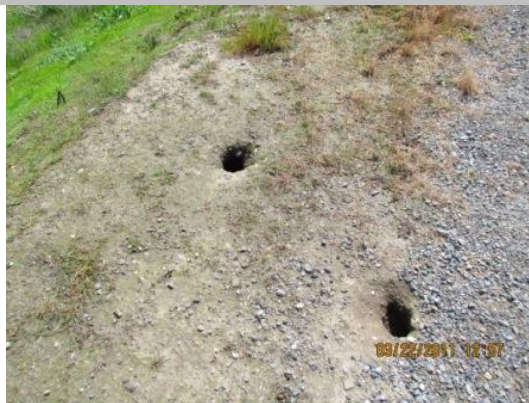
Photo 1 of 1 : SP_2017_RD0563_210_33_20170313_00028.jpg

| Rodent holes on landside shoulder. | | | | | |

Looking southeast at squirrel holes on landside shoulder.

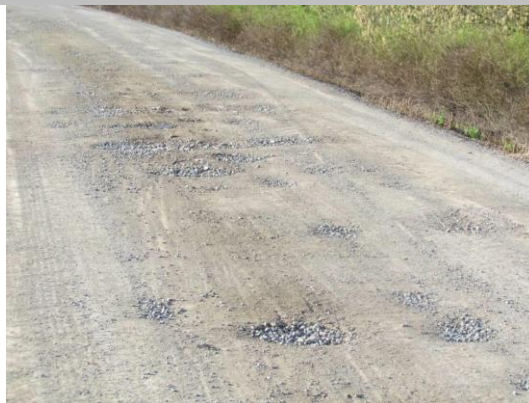
Photo 1 of 1 : SP_2017_RD0563_210_66_20170316_00244.jpg

Looking south at several potholes/ruts on levee crown.

| The roadway is passable, but should be bladed to maintain a good roadway with good gravel and a smooth surface. Some material may need to be added. | | | | | |

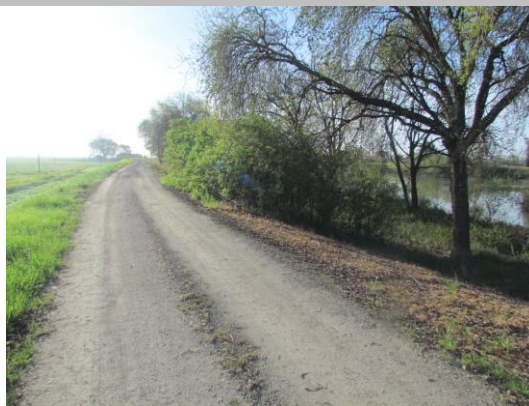
Photo 1 of 3 : SP_2017_RD0563_210_12_20170316_00245.jpg

| Dense elderberry on waterward shoulder and slope. | | | | | |

Looking southwest at dense elderberries on waterward shoulder and slope. (Spring 2017)

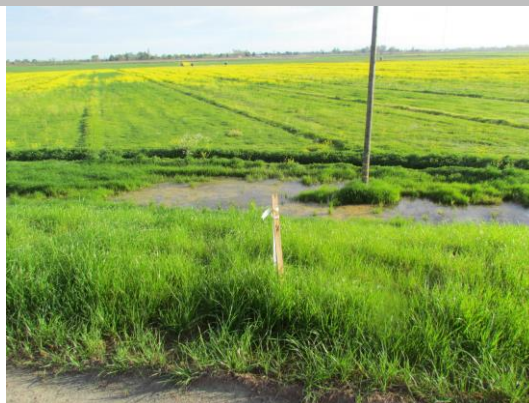
Photo 1 of 3 : SP_2017_RD0563_210_124_20170316_00248.jpg

| Seepage that was discovered during the February storm | | | | | |

Looking east at staking and seepage at landward toe and berm

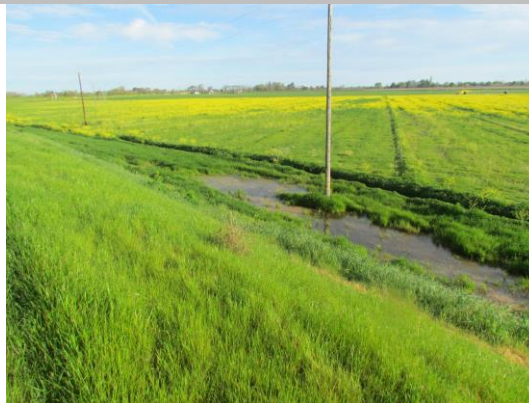
Photo 2 of 3 : SP_2017_RD0563_210_124_20170316_00247.jpg

Looking north at seepage along landward toe and berm.

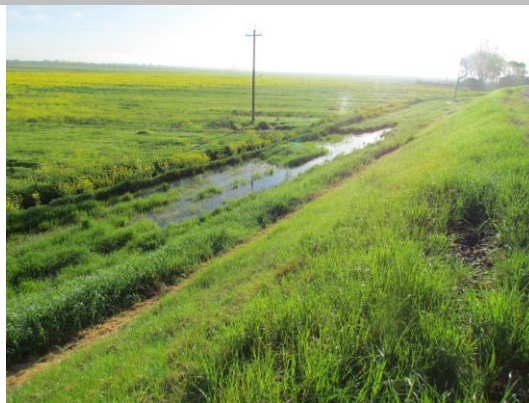
Photo 3 of 3 : SP_2017_RD0563_210_124_20170316_00246.jpg

| Seepage that was discovered during the February storm | | | | | | |

Looking south at seepage along landward toe and berm.

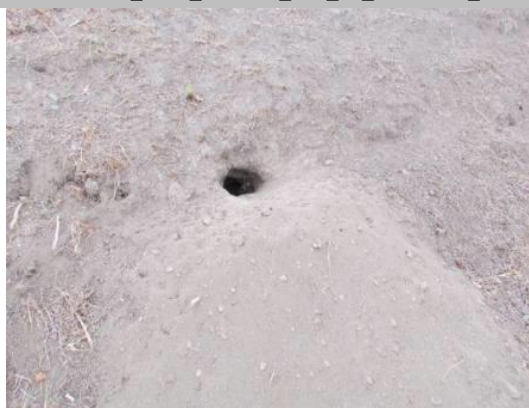
Photo 1 of 4 : SP_2017_RD0563_210_85_20170313_00081.jpg

| Rodent holes not visiable due to dense veg on landward slope. | | | | | |

Looking west at rodent hole on landside slope.

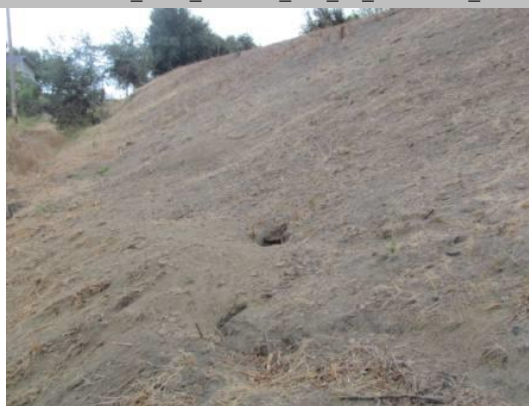
Photo 3 of 4 : SP_2017_RD0563_210_85_20170313_00083.jpg

| Rodent holes not visiable due to dense veg on landward slope. | | | | | | |

Looking southwest at rodent holes on landside slope.

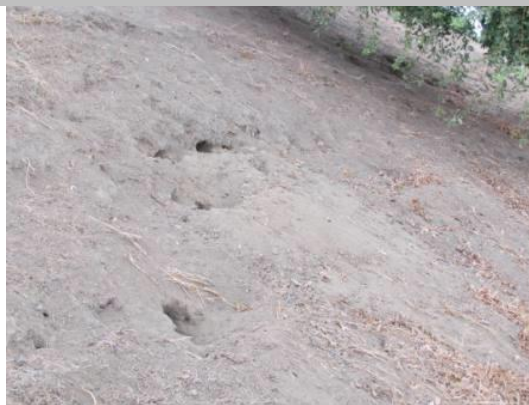
Photo 4 of 4 : SP_2017_RD0563_210_85_20170313_00084.jpg

Looking northeast at rodent holes on landside slope.

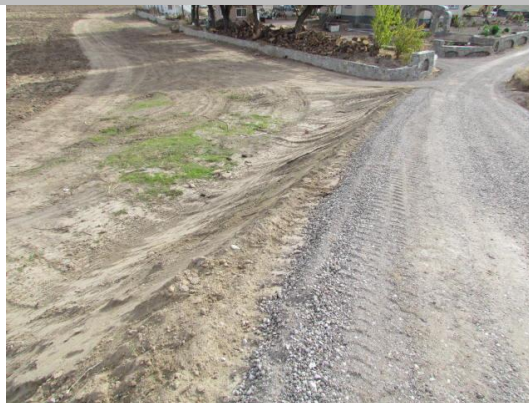
Photo 1 of 2 : SP_2017_RD0563_210_80_20170313_00078.jpg

| Landowner installed unauthorized ramp on landside slope. This ramp is not part of permit # 9146. | | | | | |

Looking east at unauthorized ramp on landside slope.

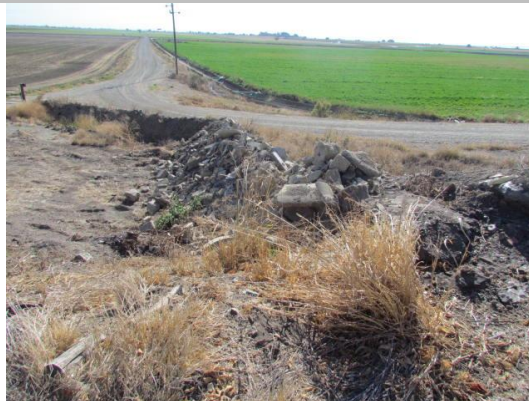
Photo 2 of 2 : SP_2017_RD0563_210_104_20170313_00106.jpg

| Landowner stockpiled concrete rubble on landward and waterward slope to stop trespassers. Landowner should replace the stockpile with a proper fence. | | | | | | |

Looking east at concrete rubble on landward slope.

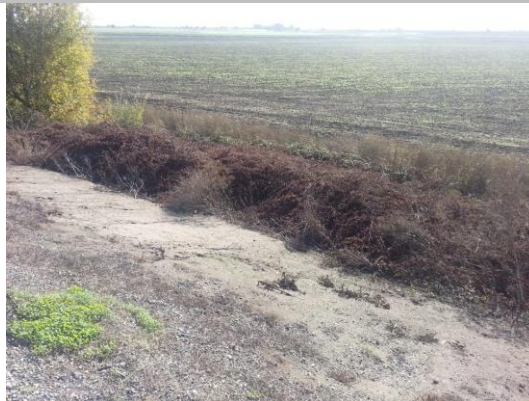
Photo 2 of 2 : SP_2017_RD0563_210_67_20170313_00051.jpg

Looking east at dead berryvines at landward toe. (Fall 2016)

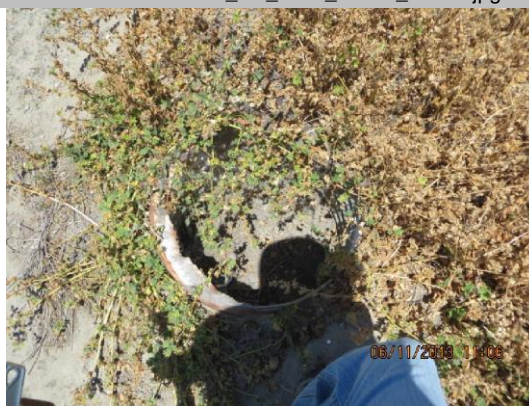
Photo 1 of 1 : UCIP_SP_2017_14885_24548.jpg

| FS_ID:14885 DS_ID:20139 EP_NO: N/A Repair Type: Non-Urgent Crossing Status: Found UCIP Comments: Abandoned and should be done so properly. Need to verify disposition of pipe. FIELD_STRUCT_DESC: *ABANDONED* 6-inch pipe through levee 4.0 feet below crown. Siphon breaker in 24-inch CMP riser on landward shoulder. Open on both ends. Originally included in 1954 O&M manual with the description 1" air valve, brass cock and cover. FS Date: 6/11/2013 | | | | | |

24-inch CMP standpipe on LS slope.

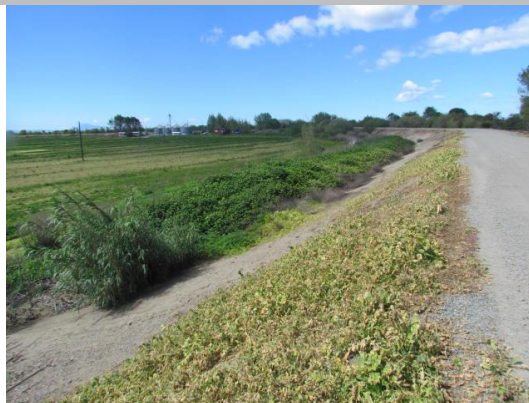
Photo 2 of 3 : SP_2017_RD0563_210_74_20170313_00059.jpg

| Dead berryvines at landside toe blocking view of toe. | | | | | | |

Looking southeast at berryvines at landward toe., (Spring 2016)

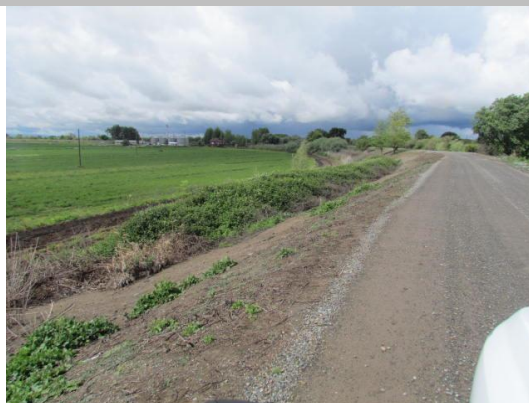
Photo 3 of 3 : SP_2017_RD0563_210_74_20170313_00060.jpg

Looking southeast at dense berryvines at landward toe. (Spring 2015)

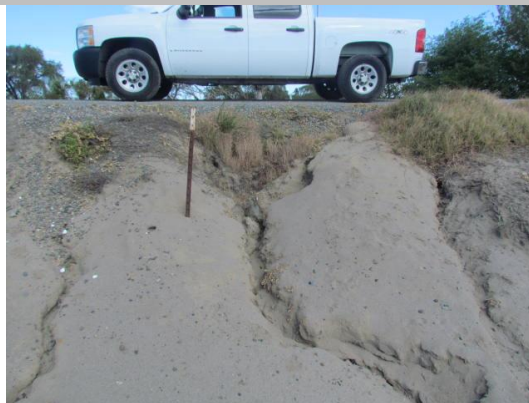
Photo 2 of 4 : SP_2017_RD0563_210_78_20170313_00072.jpg

| Slope damage on landward shoulder and slope has been in place for several inspection cycles. | | | | | | |

Looking west at rain runoff erosion on landward slope. (Spring 2016)

| S1 : Repair slope instability. | | | | | | |

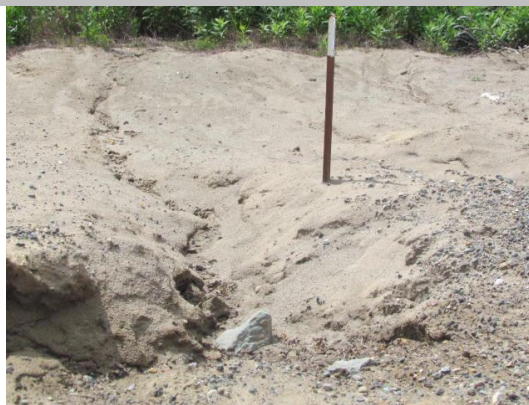
Photo 3 of 4 : SP_2017_RD0563_210_78_20170313_00075.jpg

Looking east at slope erosion. (Updated Spring 2012)

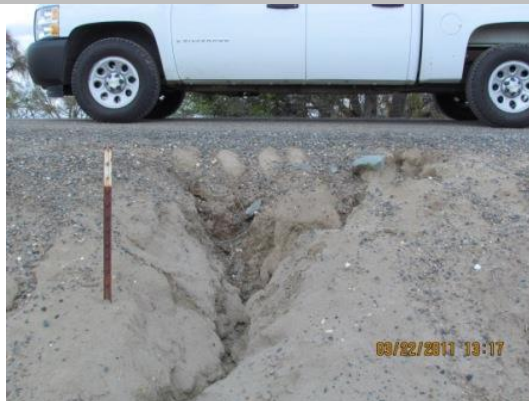
Photo 4 of 4 : SP_2017_RD0563_210_78_20170313_00076.jpg

Looking west at slope erosion cause by runoff on landside slope.

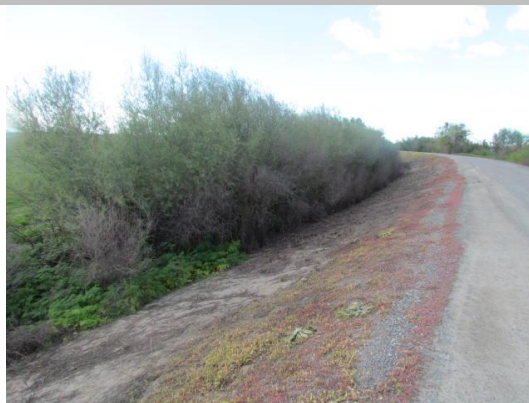
Photo 1 of 2 : SP_2017_RD0563_210_763_20170313_00149.jpg

| Dense vegetation (willows) at landward toe. | | | | | |

Looking south at dense vegetation (willows) at landward toe. (Spring 2016)

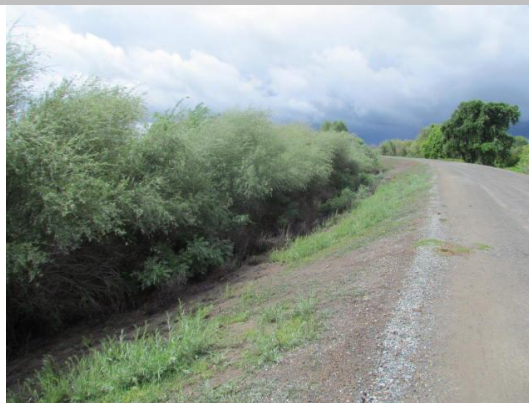
Photo 2 of 2 : SP_2017_RD0563_210_763_20170313_00150.jpg

Looking south at dense vegetation at landward slope and toe. (Spring 2015)

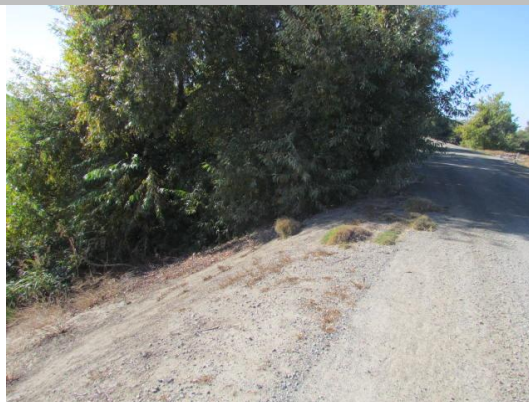
Photo 1 of 2 : SP_2017_RD0563_210_68_20170313_00053.jpg

Looking south at dense trees on landward slope.
